Investigation Into The Structural Behaviour of Mine Brick Barricade

Authors: Colin F. Duffield, Emad F. Gad and William E. Bamford

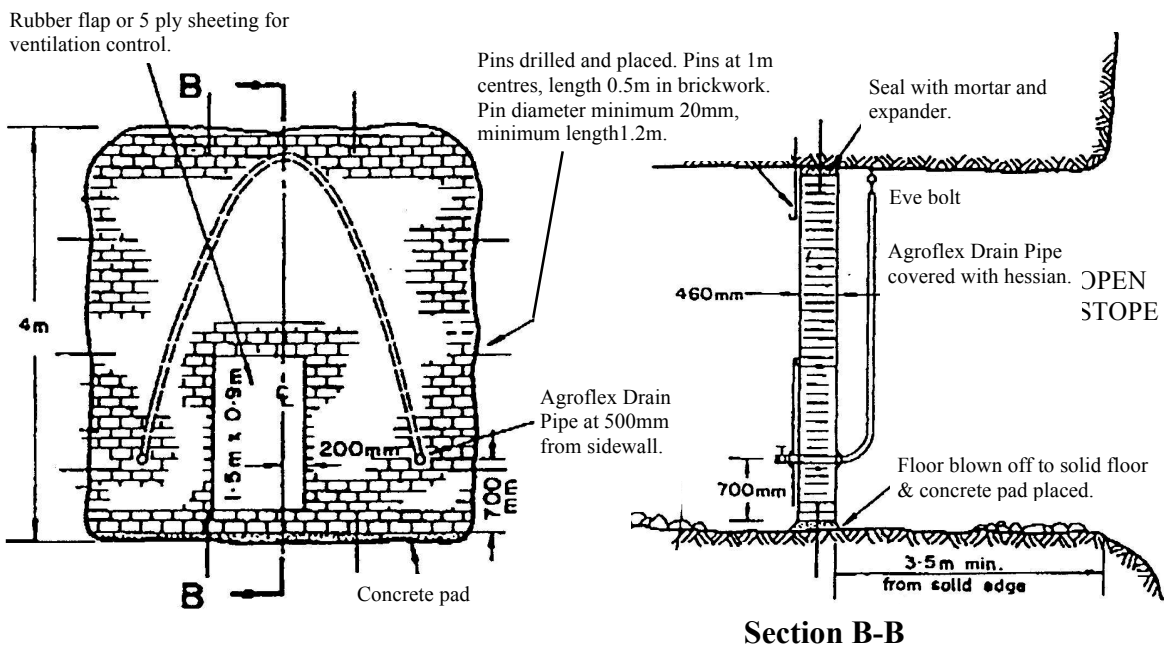
Figure 1: A typical barricade configuration (after, Beer 1986).

The failed barricade measured approximately 6m wide by 5.3m high and was 400mm thick. It was constructed from 400x200x100mm bricks in similar manner to that shown in Figure 1. A

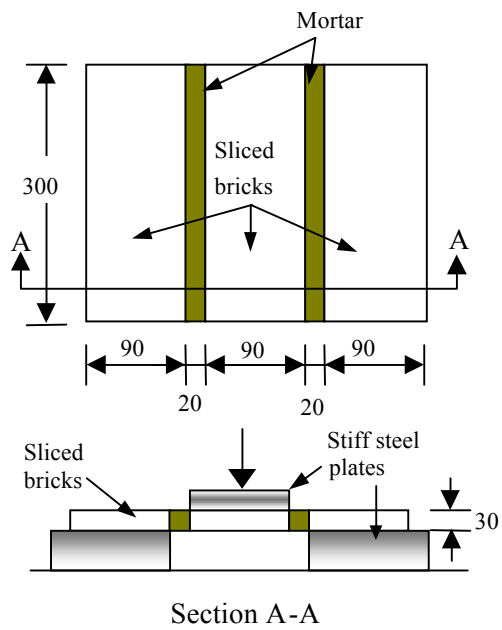
Figure 2: Typical layout of the shear tests to determine the shear strength of the bond between the mortar and brick units (dimensions are in mm).

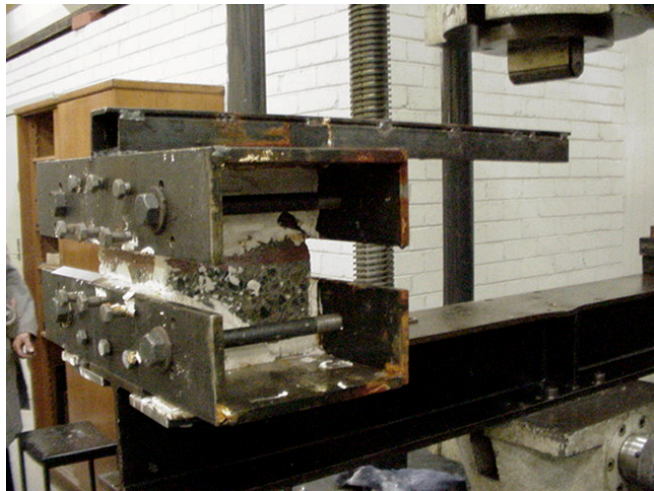
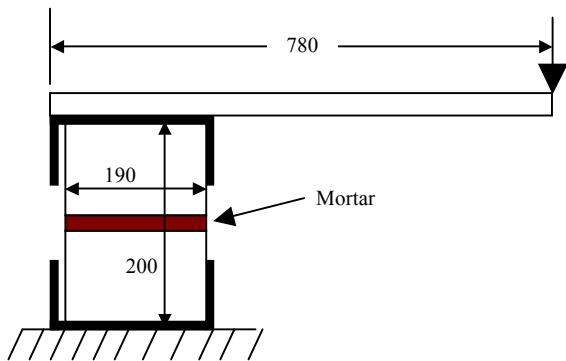
Figure 3: Typical layout of the bond wrench test to determine the tensile flexural strength of the bond between the mortar and brick units (dimensions are in mm).

- The mortar compressive strength (dry and saturated) is comparable to the specified characteristic strength of the masonry units.
- The maximum characteristic flexural strength permitted in AS3700 (2001) is 1.0MPa. The bond wrench test on the one dry specimen from the failed barricade would suggest that the characteristic flexural strength of the failed barricade may be close or exceed that maximum.

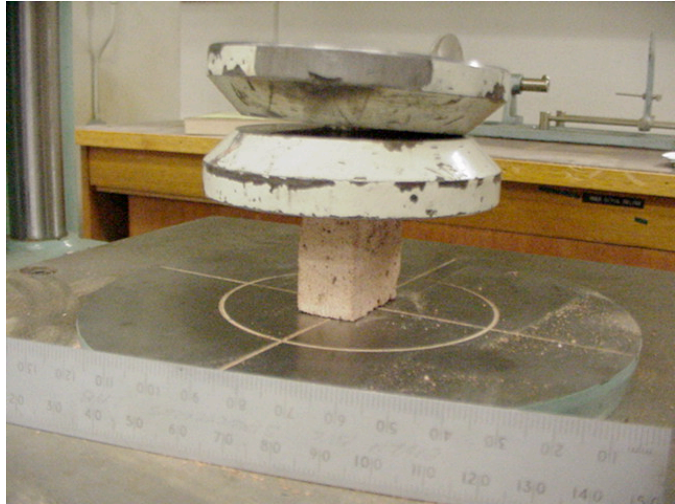
Figure 4: Typical mortar specimen used for compression test (dimensions are in mm).

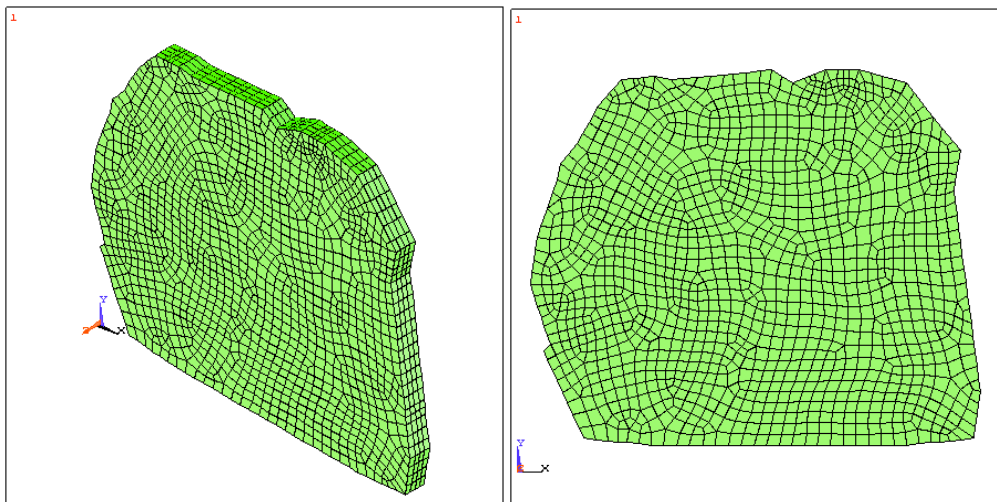
Based on the results from the FE work, it was found that the geometry of the barricade did not result in areas of high stress concentration where damage could initiate premature failure. In addition, from the form of the stress distribution, the barricade could be simplified for other analytical analysis as a rectangle.

Figure 6: Isometric and front view of the FE model of failed barricade (it is approximately 6m wide, 5.3m high and 400mm thick).

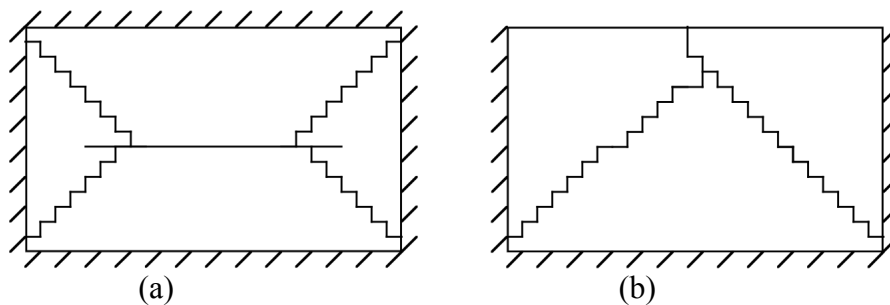
- For panels which are simply supported on four sides the first crack is always along a bed joint at mid-height of the panel. Following the formation of this crack the upper and lower halves of the panel behave independently as panels with half the original wall height (Figure 7a).

- Where adjacent sides are both supported, diagonal cracks initiate and radiate from the corner following the mortar joints. These diagonal cracks continue until they meet a free edge, a centre horizontal crack or another horizontal crack. When diagonal cracks intersect, a vertical crack develops and propagates to the top edge of the panels for walls supported on three sides Figure 7b).

Figure 7: Typical cracking patterns: (a) wall simply supported on four sides; (b) wall simply supported on three sides.

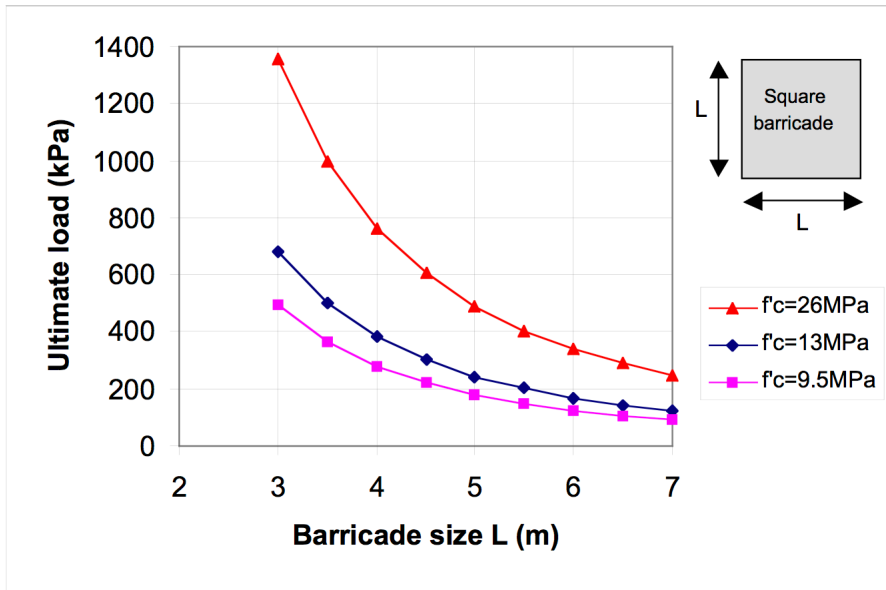
It should be noted that the ultimate capacity of the barricade is also sensitive to the physical dimensions of the slab (barricade). This is demonstrated in Figure 10 where the capacity of several square barricades is calculated. A small change in dimensions would result in a significant change in capacity.

Figure 10. The ultimate load (w_u) for square barricades with 400mm thickness and various compressive strengths (f'c).

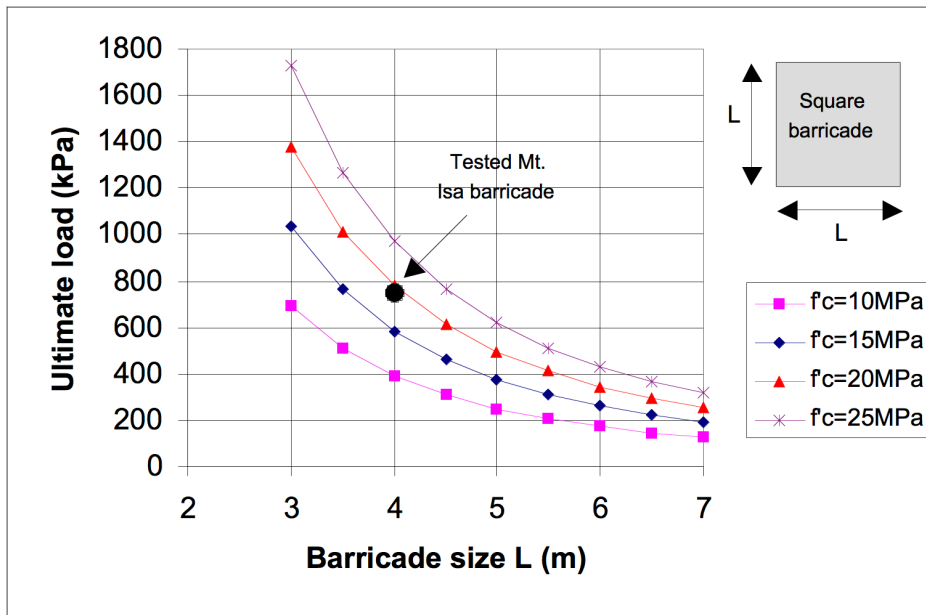
Figure 11. The ultimate load (w_u) for square barricades with 460mm thickness and various compressive strengths (f'c).

It is clear from Figure 11 that the actual failure pressure for the Mount Isa barricade (750 MPa) falls within the bounds of the predicted capacity for compressive strength of masonry between 15 and 20MPa. While this range is higher than the reported characteristic values, they may be representative values of the tested situation.
